TOWN of BROOKLINE
 Massachusetts
 Department of Public Works

Item # 2: WASHINGTON STREET COMPLETE STREETS PROJECT KICKOFF

FUNCTIONAL DESIGN REPORT

Rehabilitation of Washington Street Brookline, MA

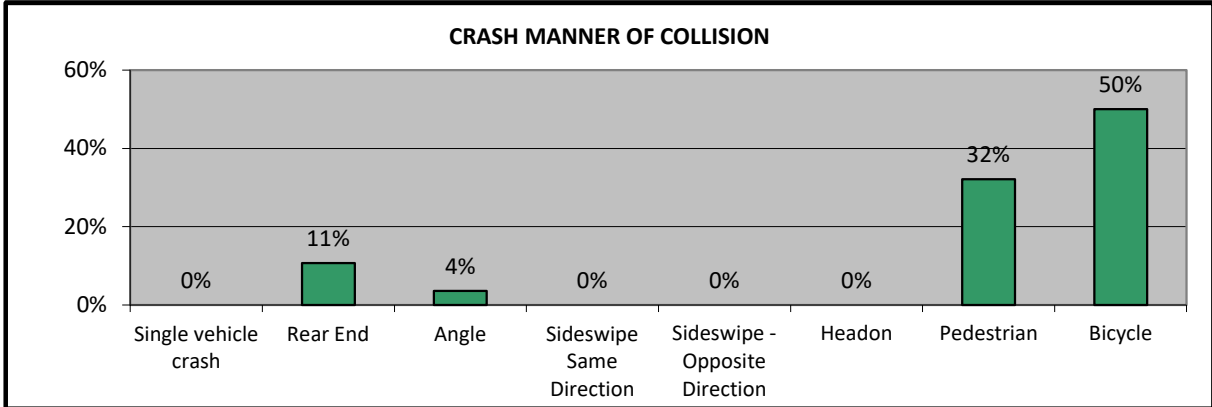
Crash Data Summary Charts
Figure 1. Washington Street at Beacon Street, Brookline, MA

Summaries based on crash reports obtained from the City of Brookline Police Department.

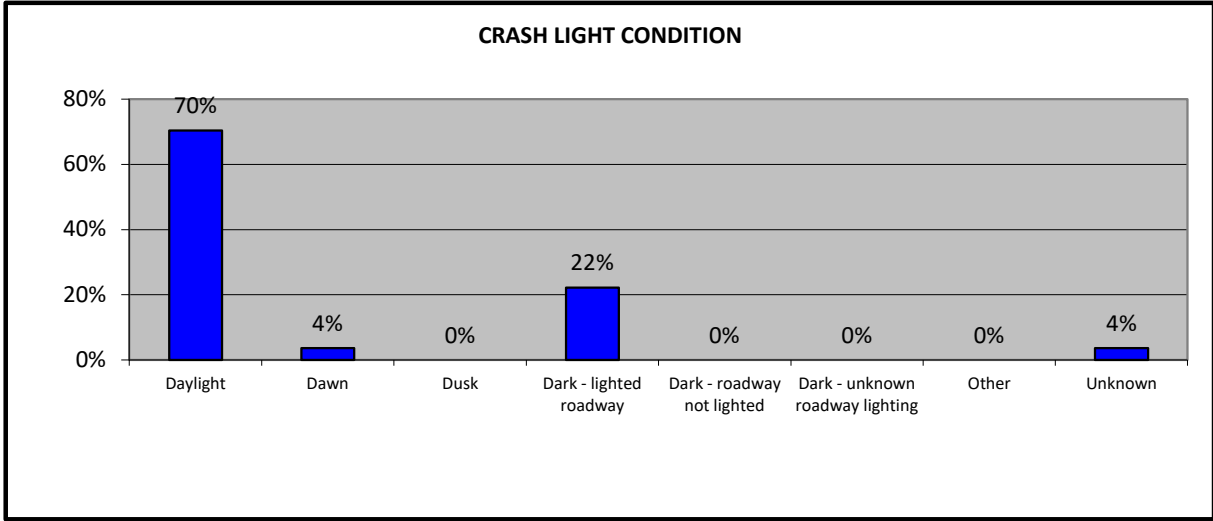
Crash Data Summary Charts
 Figure 4. Washington Street at Beacon Street, Brookline, MA
